Manhole Inspection Summary

Manhole # S13WW_008MH

Insp Date: **4/29/09 11:30 AM**

Location Address: **3401 CARLINS PARK DR** Cross Street: **DRUID PARK DR**

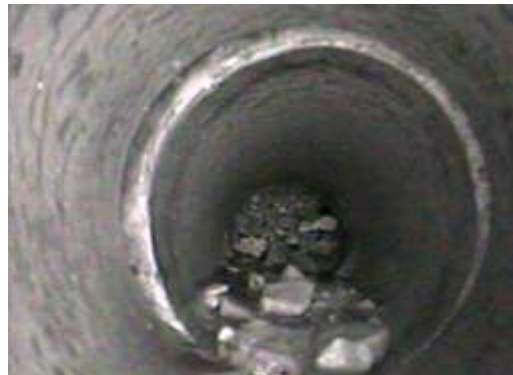
DEBRIS IN SVC CONN.

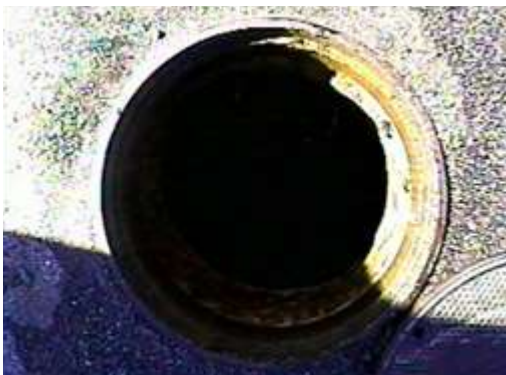
Defect 1

Frame Offset: **3** (in.) Condition: ☒ Sound ☐ Cracked ☐ Leaks

OFFSET FRAME

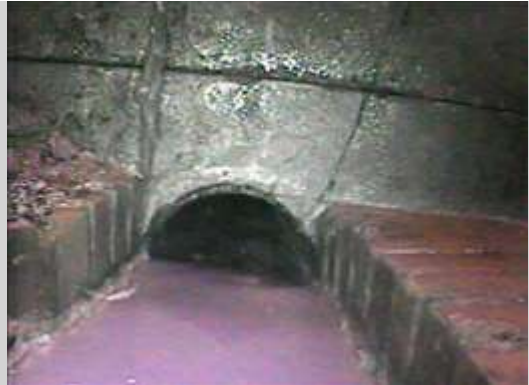
12 O'Clock Outflow

10 in. Circular Gravity Sewer
Pipe Out @ 12 O'Clock

Pipe Height: (in.) Direct
Pipe Material: **Clay** ☐ Pipe Lined
Invert Depth: **16.00** (ft.) Flow Characteristics: **Slow**
Deposits: ☒ None ☐ Mud ☐ Sludge ☐ Debris ☐ Grease
Silt Depth: (in.) Deposits Extent:
Infiltration: **None** Pipe Seal Cond: **Sound**

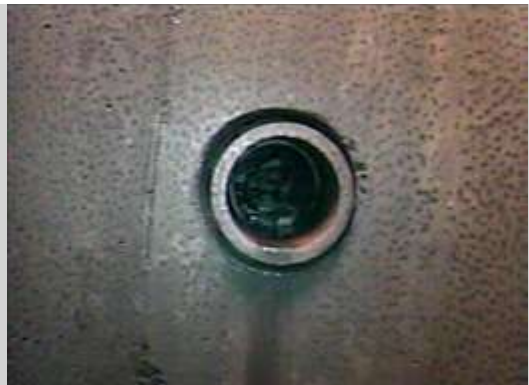
6 O'Clock Inflow

6 in. Circular Gravity Sewer
Pipe In @ 6 O'Clock

Pipe Height: (in.) Direct
Pipe Material: **Clay** ☐ Pipe Lined
Invert Depth: **6.70** (ft.) Flow Characteristics: **Slow**
Deposits: ☒ None ☐ Mud ☐ Sludge ☐ Debris ☐ Grease
Silt Depth: (in.) Deposits Extent:
Infiltration: **None** Pipe Seal Cond: **Sound**

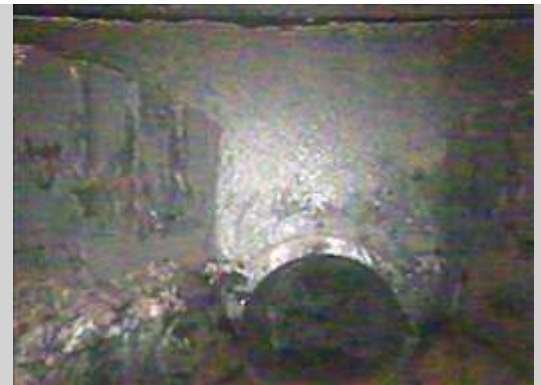
Drop In @ 6 O'Clock

Drop: **Outside Direct**
Angled: Reading: (ft.)
Inv Depth: **15.85** (ft.)
Drop Condition: **Partly Clogged**

Connects To: **House connection / Service line**

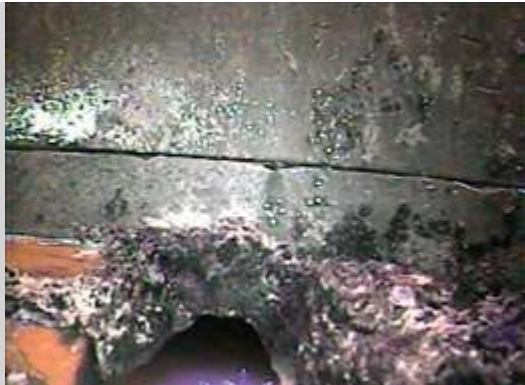
9 O'Clock Inflow

10 in. Circular Gravity Sewer
Pipe In @ 9 O'Clock

Invert Depth: **15.90** (ft.) Flow Characteristics: **Slow**

Infiltration: **None** Pipe Seal Cond: **Sound**
